## EL-Modulinspektion im Feld mit KI-gestützter Fehleranalyse

7. Niedersächsisches Forum Solarenergie

Dr. Jan Schlipf  
Aerial PV Inspection GmbH  
Im Johannistal 31a  
52064 Aachen  
[www.aepvi.com](http://www.aepvi.com)

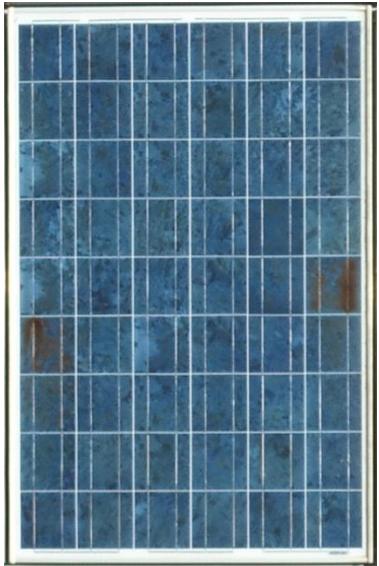
**Visual**  
VI

1,000 – 10,000 mod./ day

glass breakage, scratches  
soiling, snail trails  
discolouring

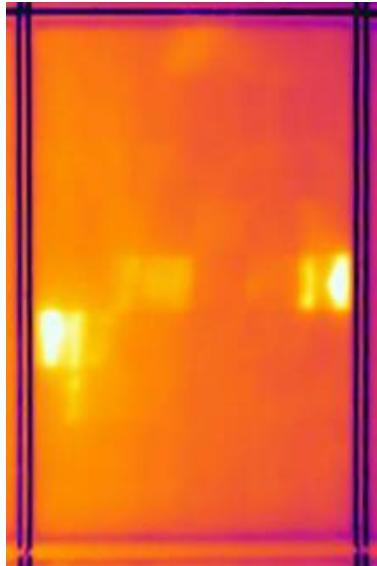
**Thermography**  
IR-Mpp

25,000 – 60,000 mod./ day

inactive modules  
lost or defect substrings  
hot-spot patterns

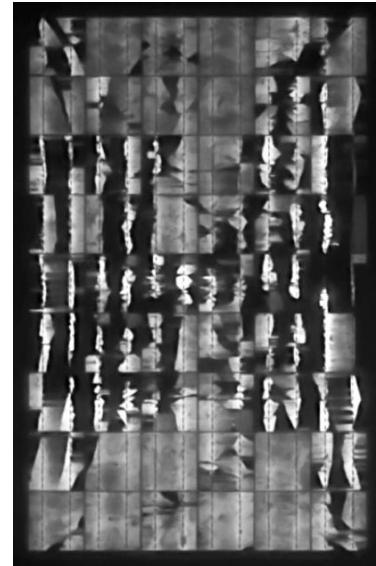
**Electroluminescence**  
EL

800 – 4,000 mod./ night

as IR-Inv, plus: cell cracks  
busbar and contact problems  
early stage PID and LeTID

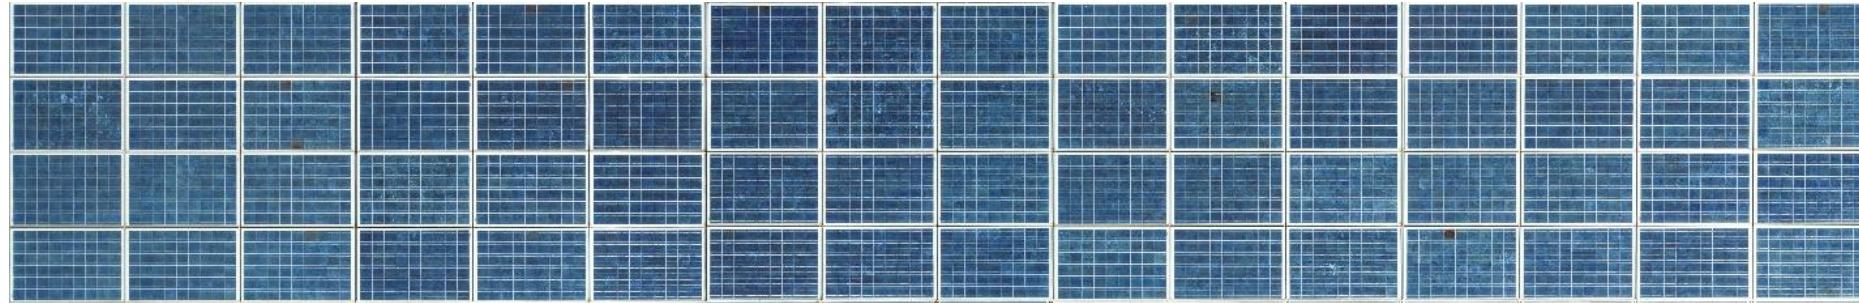
VI

Revealing root causes of hot-spots by electroluminescence

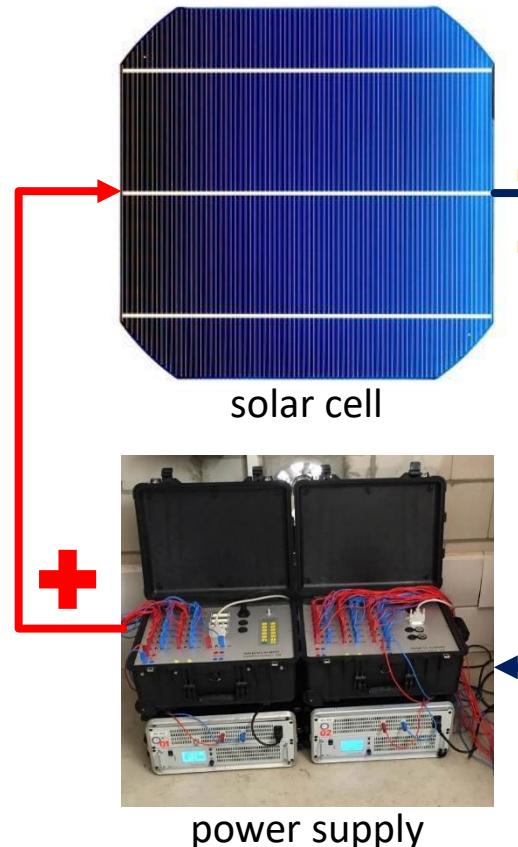
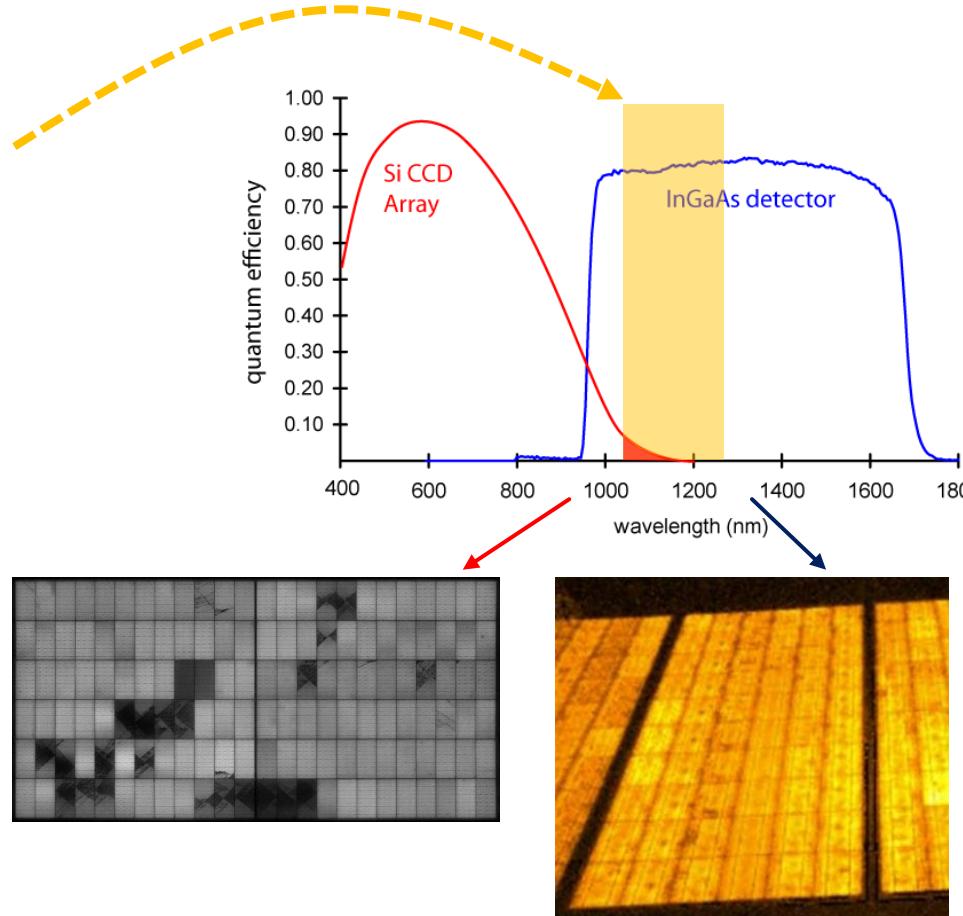
- Power is supplied to the PV module (reverse operation)
- Electroluminescence: Cells radiate in a narrow band around 1,150 nm (NIR: near infrared)
- NIR radiation can be recorded by Si-CCD or InGaAs sensors: we use Si-CCD

NIR radiation

Si EL image  
in darkness  
high resolution  
consumer cameras

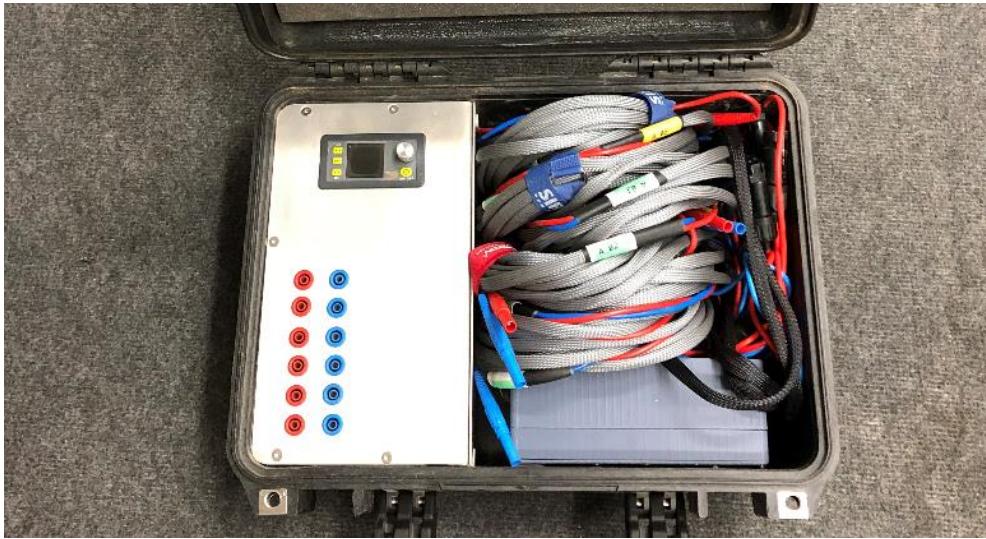
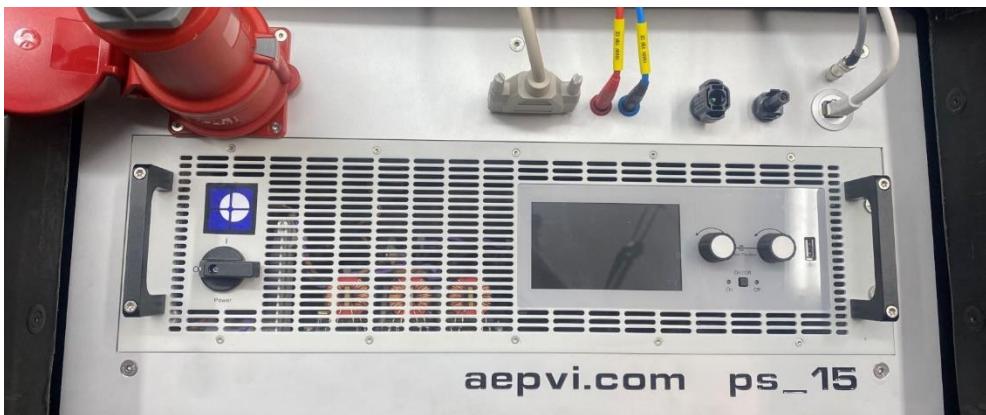
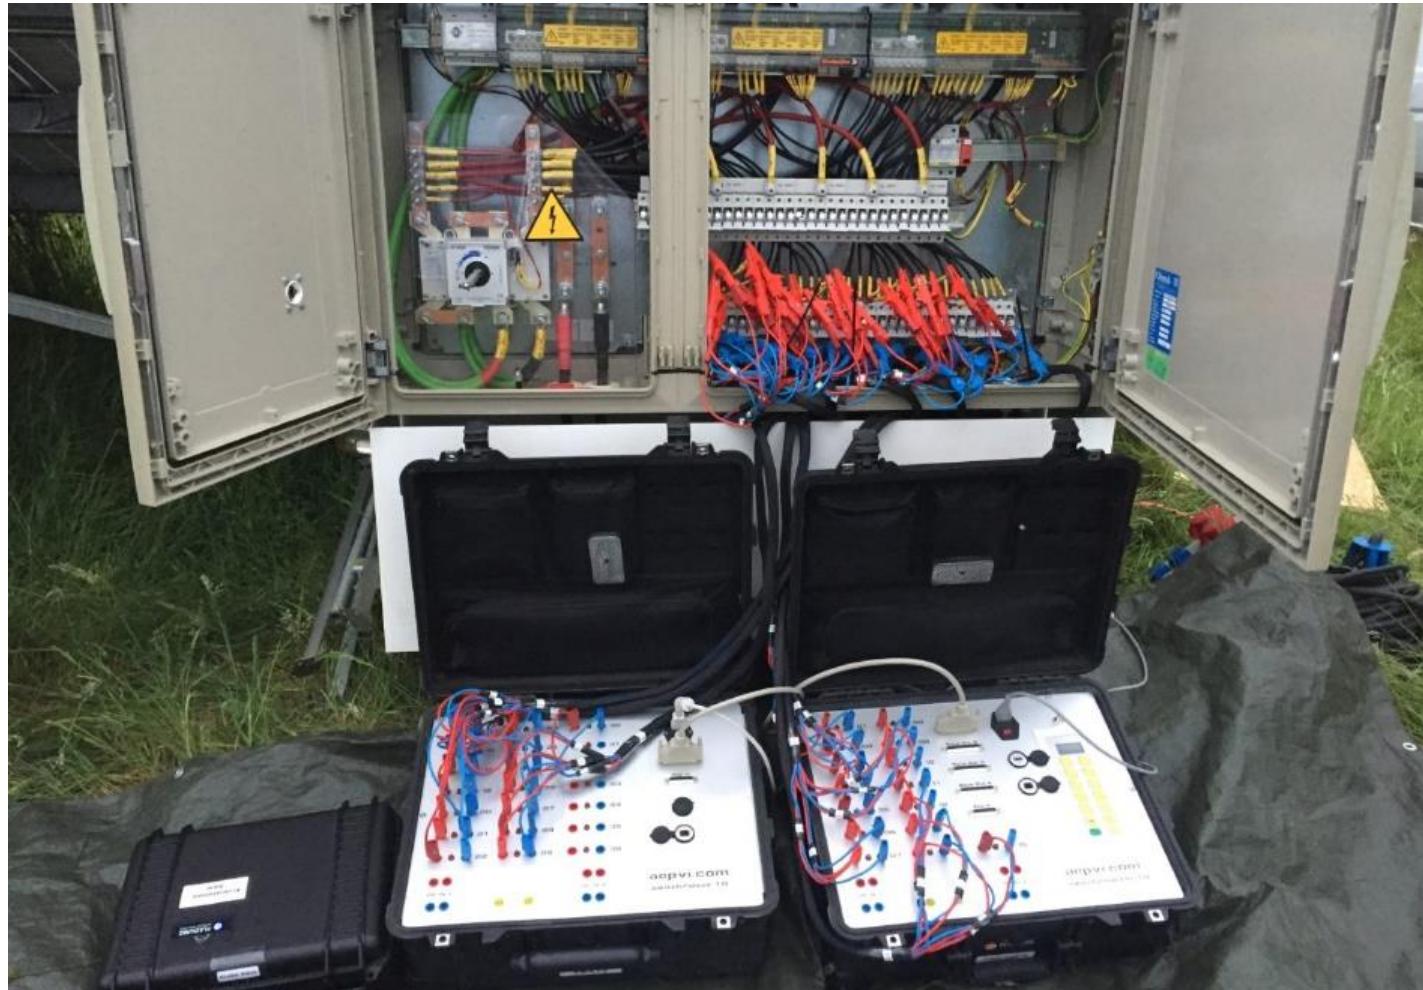
- Switches for energizing one module or up to 100+ strings
- 2x 15 kW for multi-string energizing

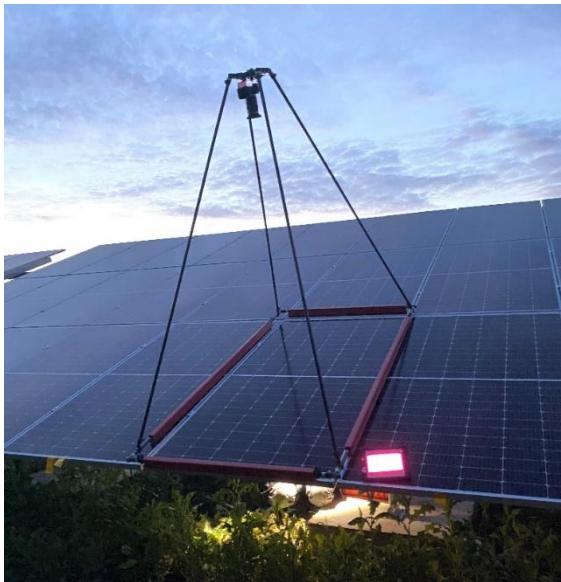
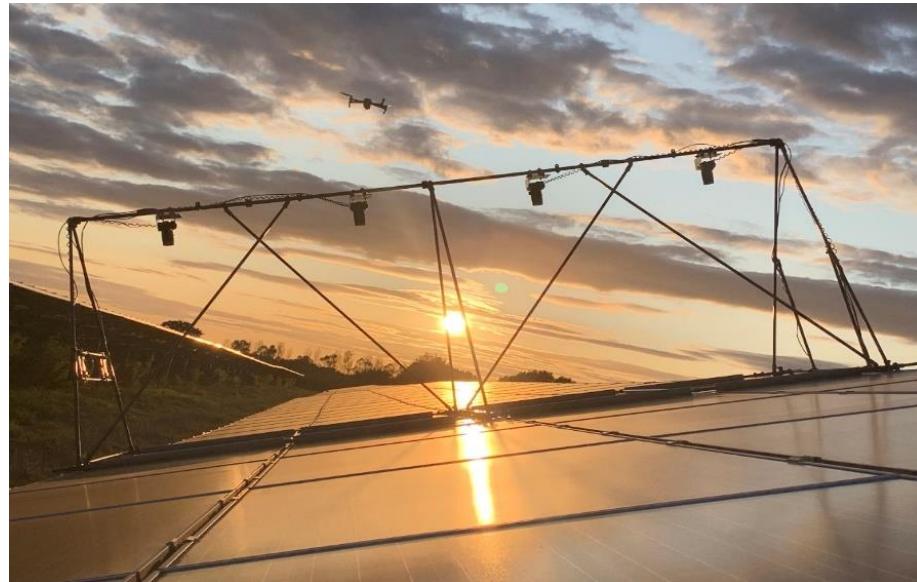
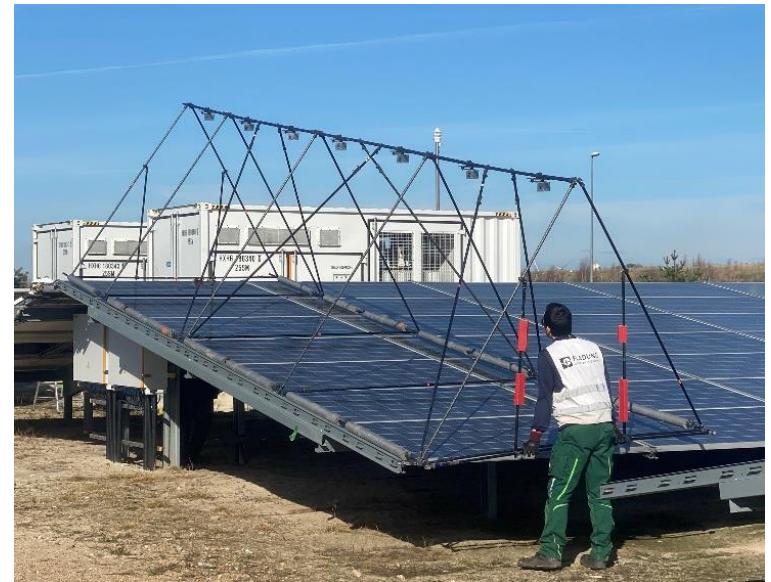
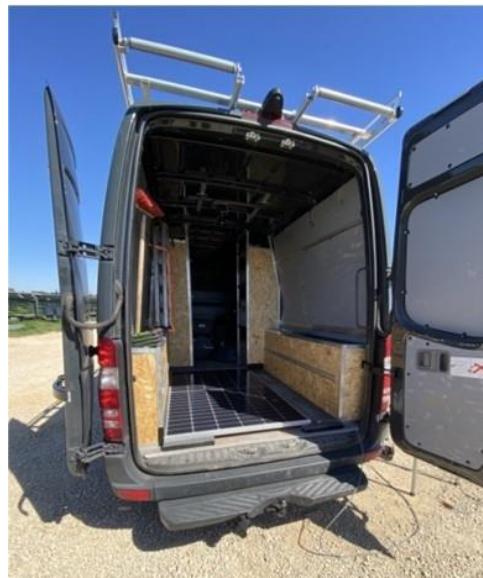
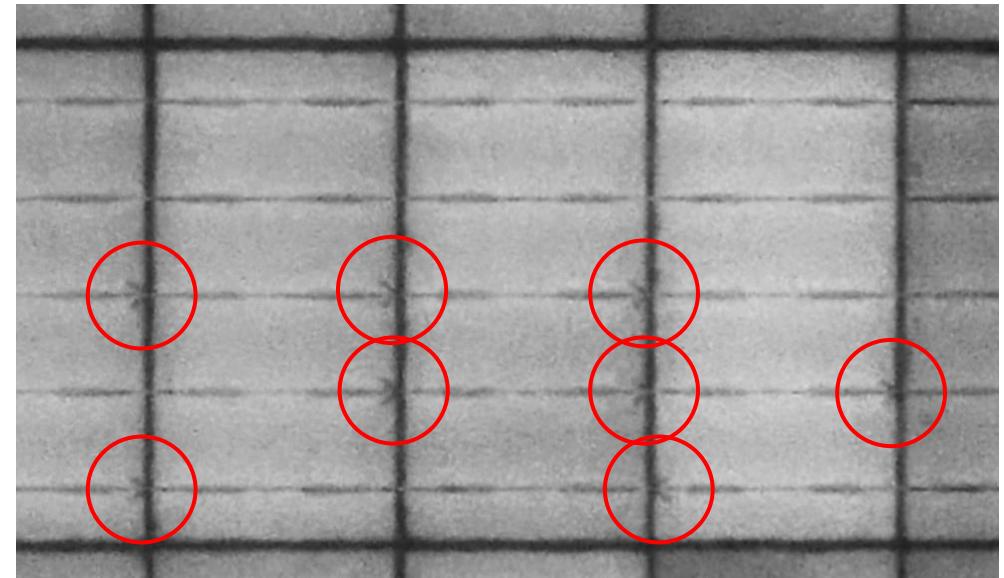
- Tripods and Bridges for 1 to 8 modules
- Mobile lab: on-site module check before installation
- Highest quality EL images

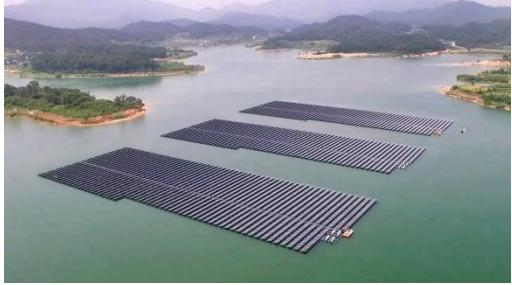
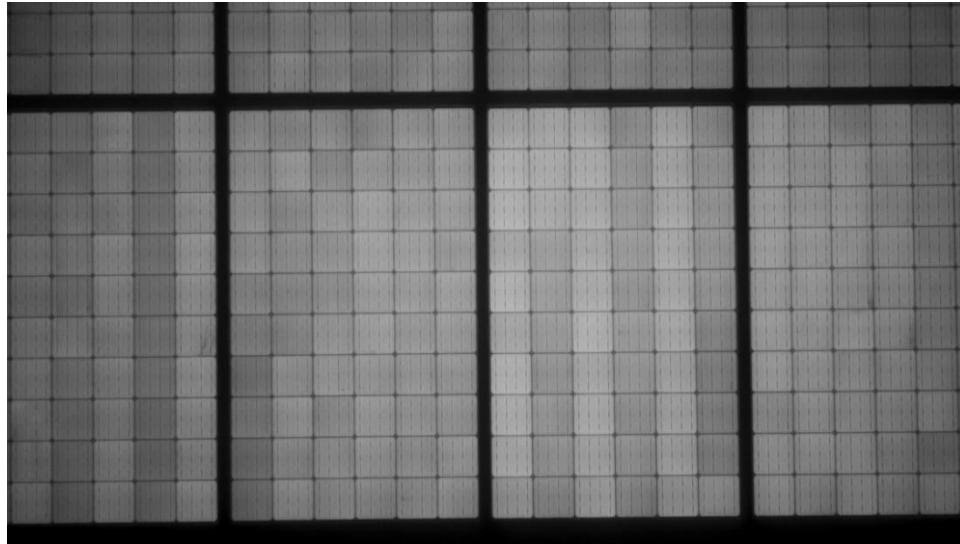
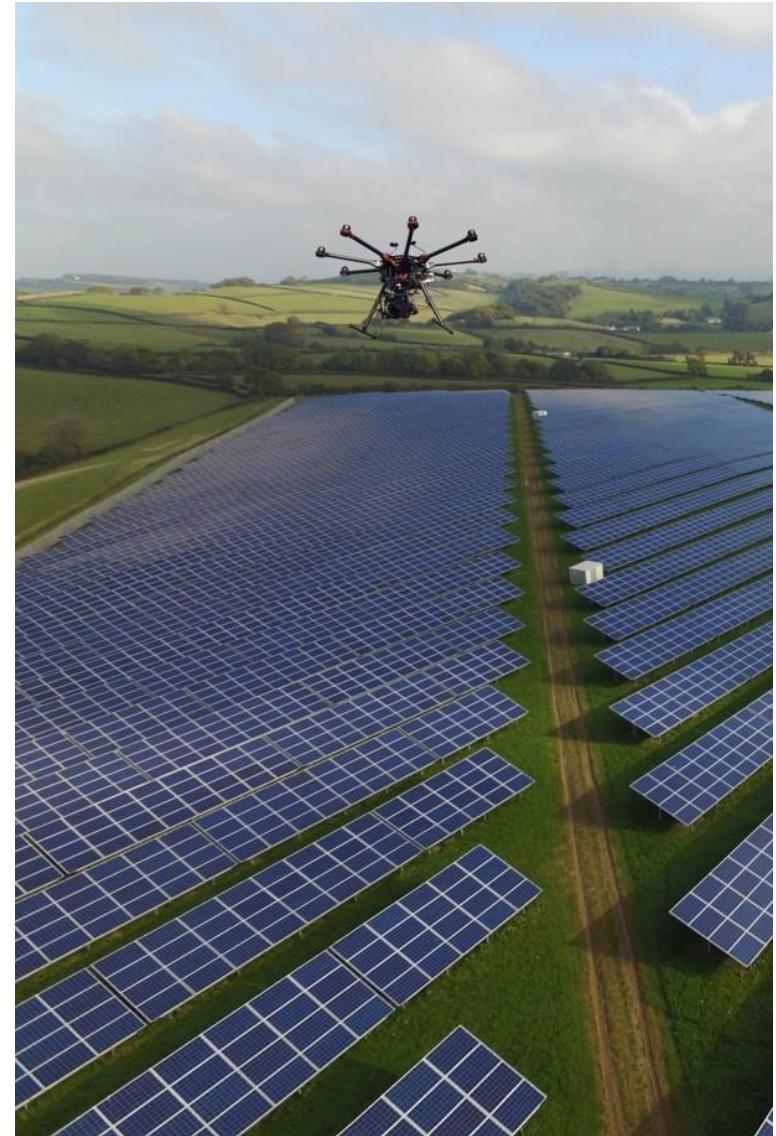
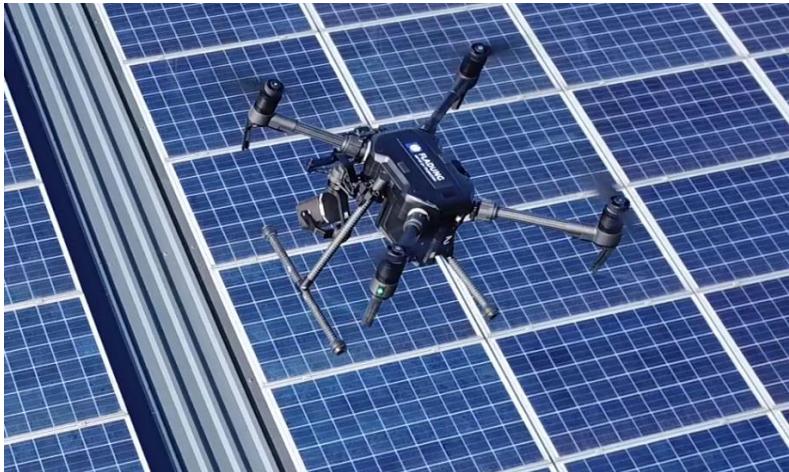
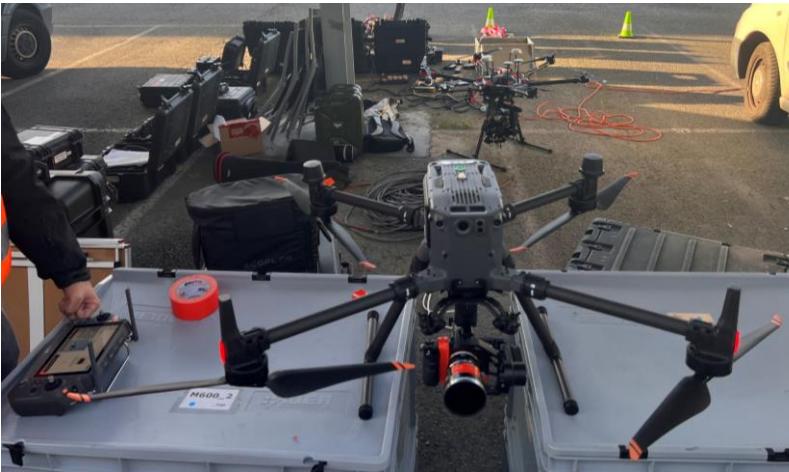
- For inspections by EL, IR, and VI
- Rooftops, floating
- Images and videos

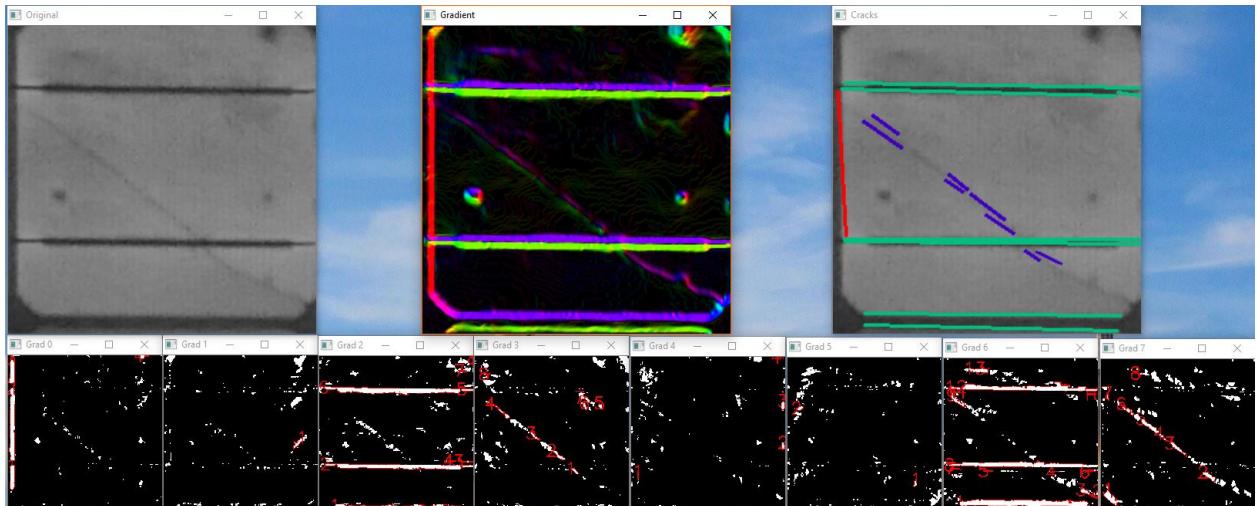
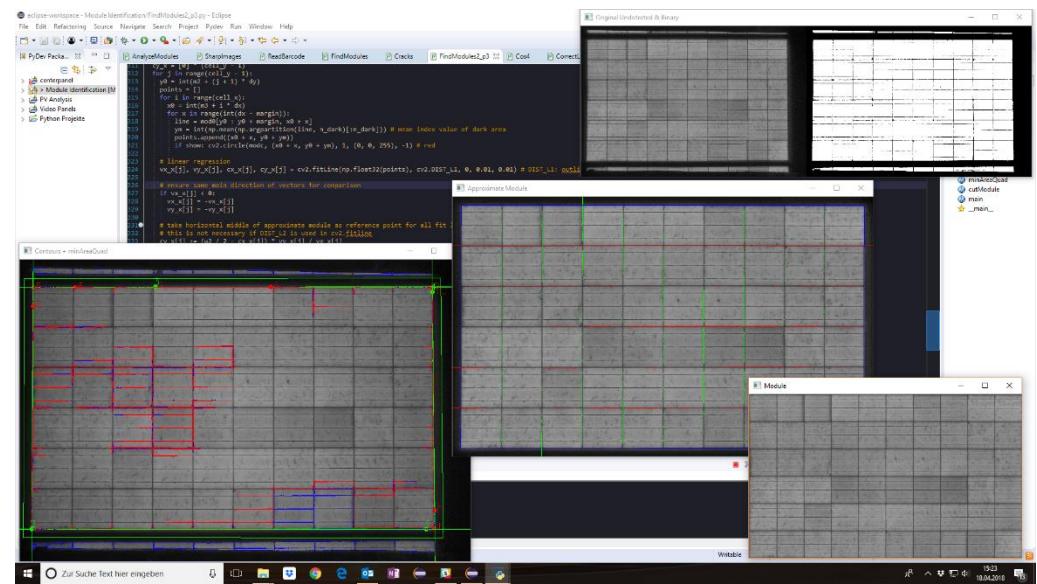
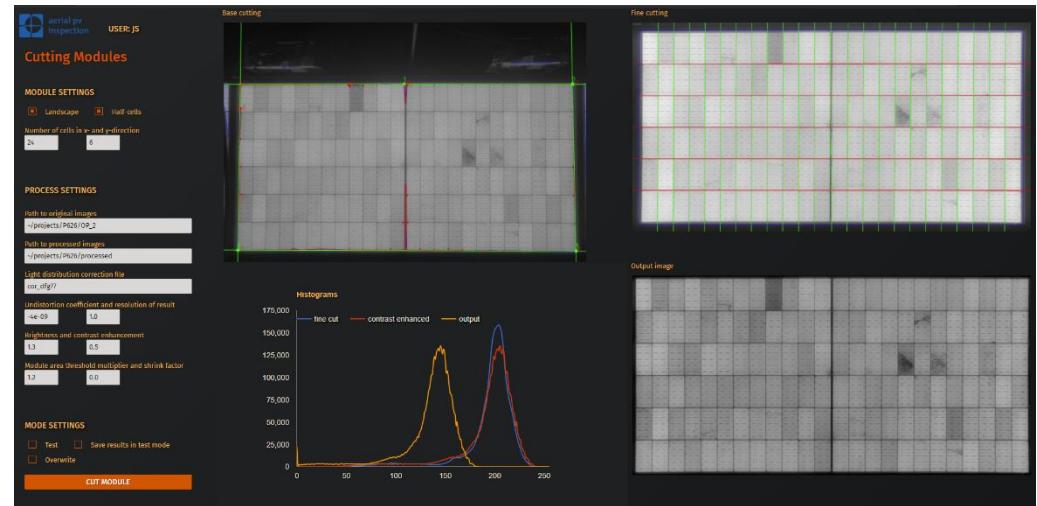
**Module area identification and cutting:**  
Locate module in EL image, rectify, and cut

**Image enhancement:**  
Correct light distribution, enhance contrast

**Crack detection:**  
Identify cracks by shape (experimental)

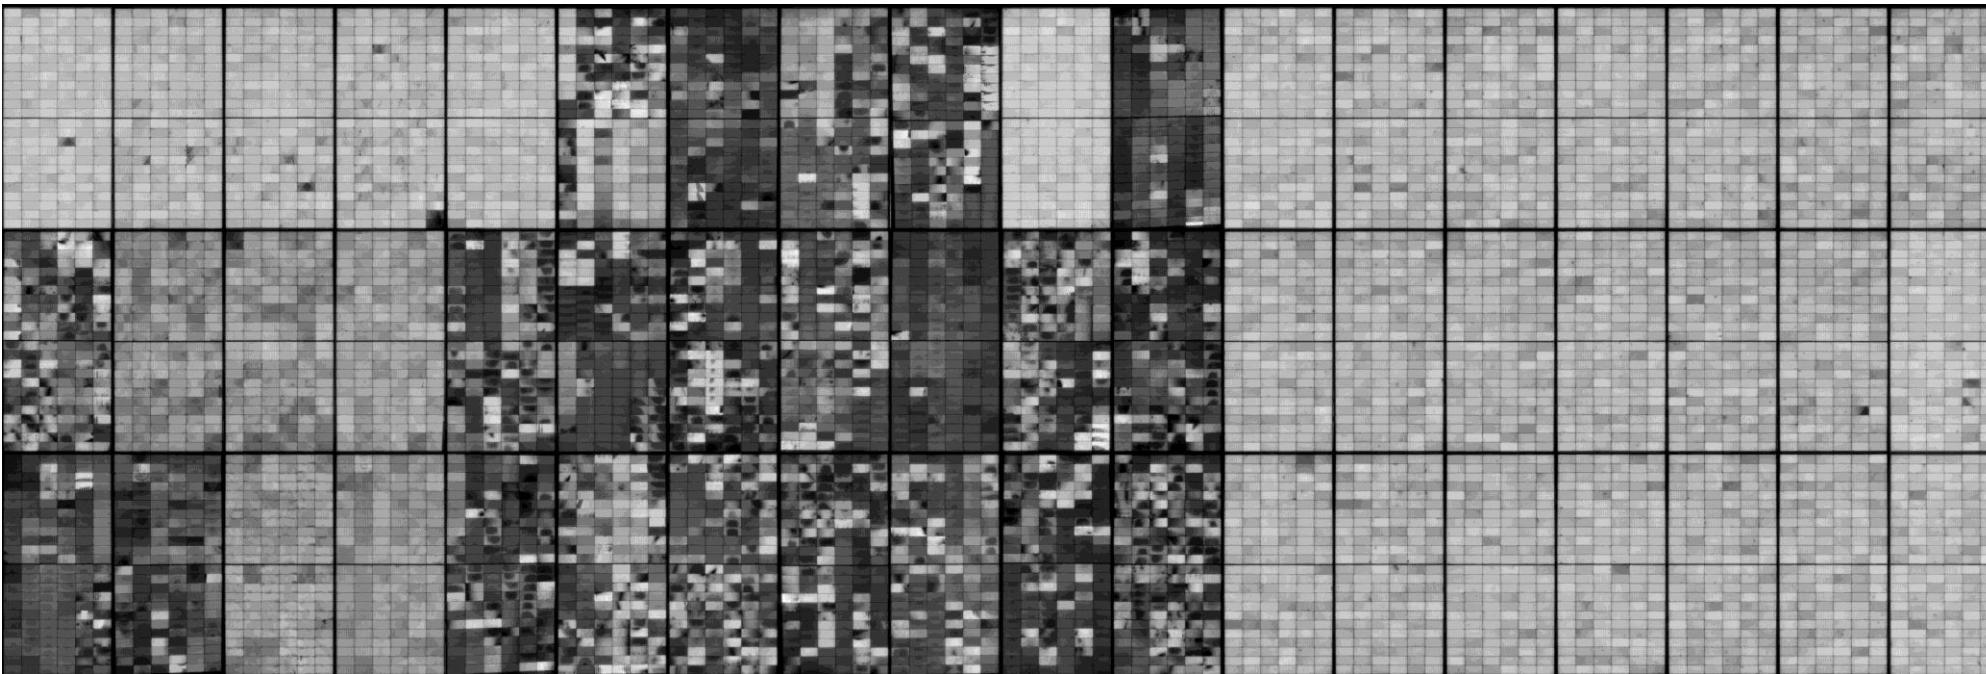
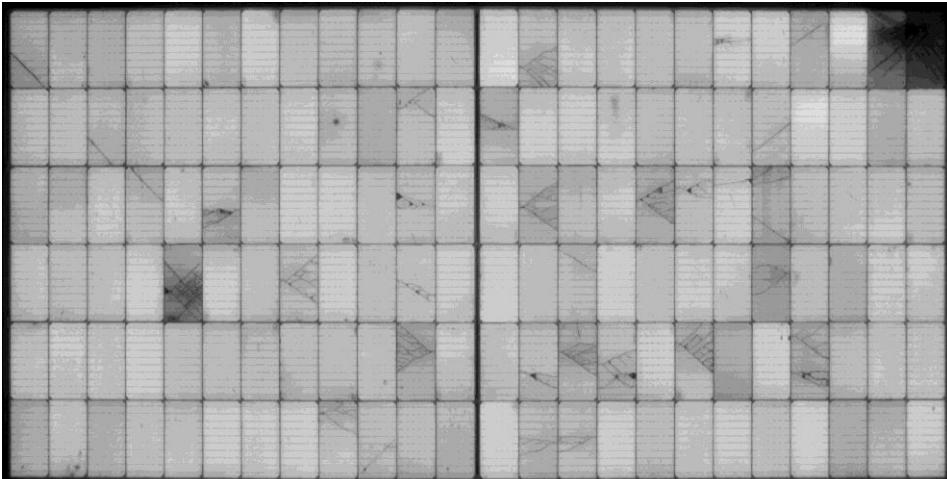
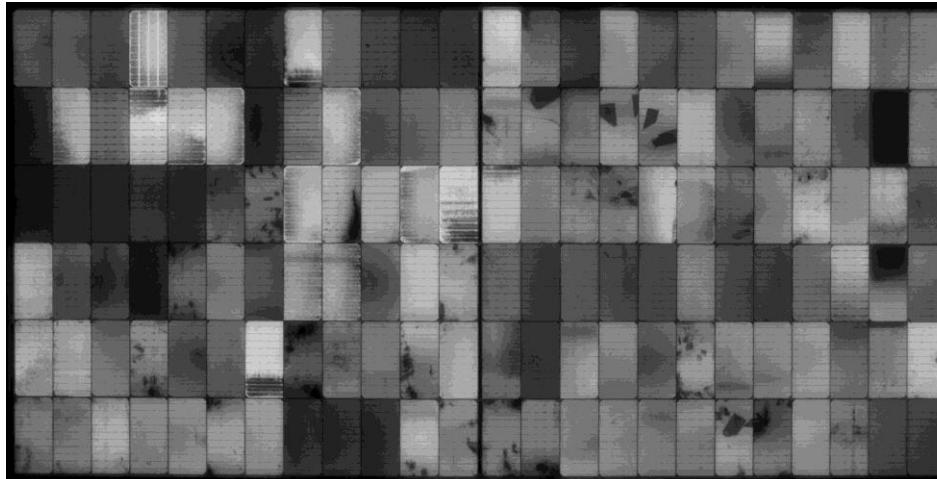
- Cracks and scratches: typical faults induced by bad module handling during transport or installation
- Cell inhomogeneities: typically from module production, not all are faults

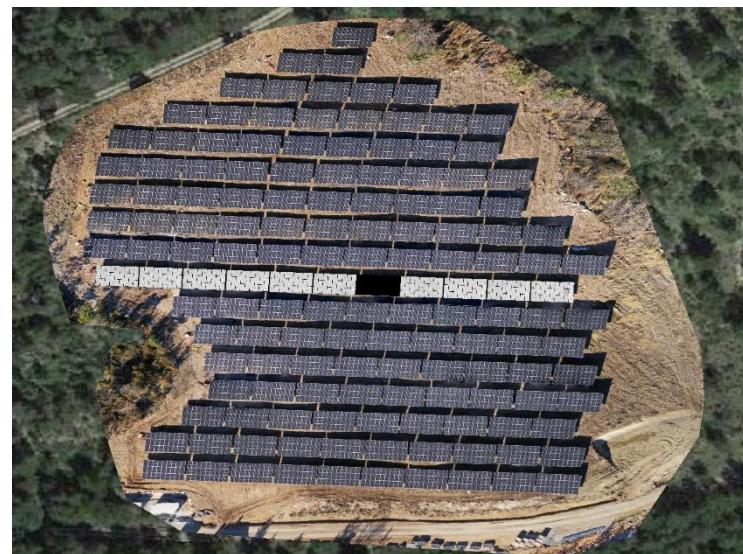
3D map

# 3D Visualisation
